PUNCH ITEM #17

Cracked corner bead at closet return, Room 412

Building A > Floor 4 > Guest Room 412

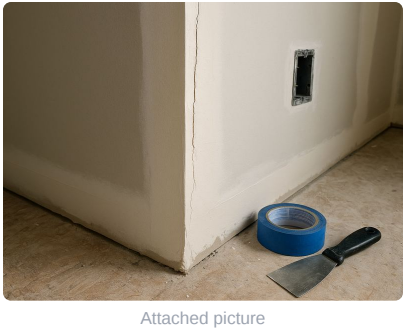
Vertical hairline crack running the full height of the corner bead at the closet return wall, likely from framing movement before taping. Crack has telegraphed through the first coat of joint compound. Needs re-tape, skim, sand, and touch-up paint to match adjacent wall (Sherwin-Williams SW 7005 Pure White, eggshell).

On it. That's from the header movement we saw on 4 — same fix as 409 and 415. Will tape, skim, sand, and prime/paint to match. Should have it knocked out by end of week.
- Drywaller Dan (Interiors Foreman) commented on **Monday, July 13, 2026 at 3:40pm**

Corner re-taped, skimmed in two coats, sanded, and painted to match (SW 7005 eggshell). After photo attached — no telegraphing, clean line. Ready for your sign-off.
- Super Sam (Site Superintendent) commented on **Tuesday, July 14, 2026 at 11:05am**

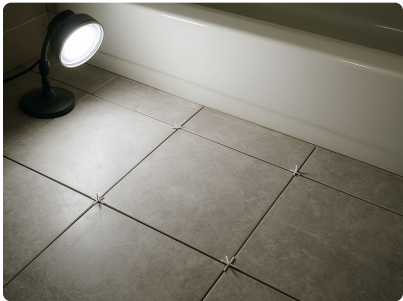
Attached picture

Bathroom floor tile grout is incomplete near the tub apron — several joints ungrouted, spacers still in place, and grout haze not wiped down on adjacent tiles. Grout spec is unsanded, color 'Warm Gray' to match wall tile.

Yep, that room got skipped when we swapped crews mid-week. Sending a guy back tomorrow to grout, pull spacers, and clean haze off the whole floor, not just the gap.
- Drywaller Dan (Interiors Foreman) commented on **Tuesday, June 30, 2026 at 4:22pm**

Grouted, sealed, spacers pulled, haze wiped down on the full floor. Caulked the tub apron while we were in there too. After photo attached.
- 
- Super Sam (Site Superintendent) commented on **Wednesday, July 1, 2026 at 10:15am**

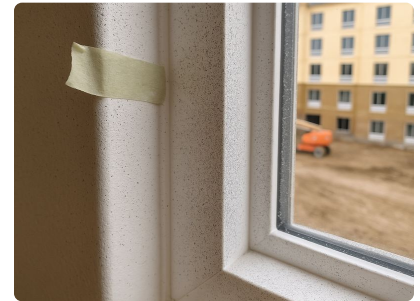
Attached picture

Wall paint overspray (SW 'Agreeable Gray') speckled across the vinyl window frame and the edge of the glass from the spray pass on the accent wall. Masking either wasn't installed or came loose. Needs frame wiped/scraped clean and glass detailed without damaging the low-E coating.

Dan — your paint crew oversprayed the window frame in 511, masking must've come loose. Need it cleaned up, this room's on the sample-room list for ownership.

Ugh, sorry about that — we'll get it scraped and detailed. Since it's a sample room I'll also re-run the caulk line at the frame so it looks sharp for the walk.

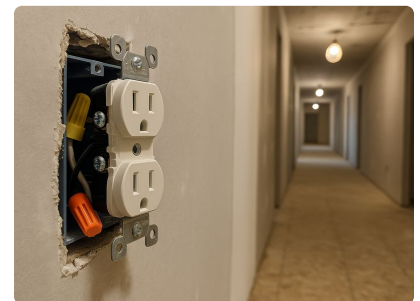
Attached picture

Duplex receptacle in the Floor 3 corridor has no cover plate installed — wiring and device yoke exposed at a location guests will pass once the floor opens. Flagged high priority given life-safety/exposure concern ahead of the fire marshal walk.

On it — that's leftover from the corridor punch sweep, plate order was short a few pieces. Got stock in now, closing the gap today.
-

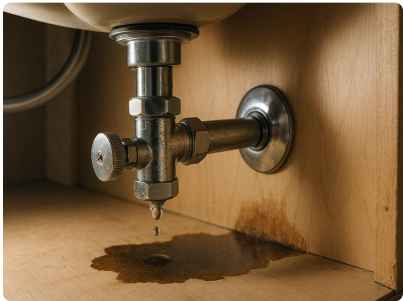
Attached picture

Angle stop supply line under the lavatory sink is weeping at the compression fitting, water staining visible on the cabinet base. Needs the fitting re-made and the cabinet base checked for water damage before finish flooring goes in.

Copy that. Compression fittings on that lot were a bad batch, we've seen two others do this. Re-making the joint and checking the cabinet base for damage.
-

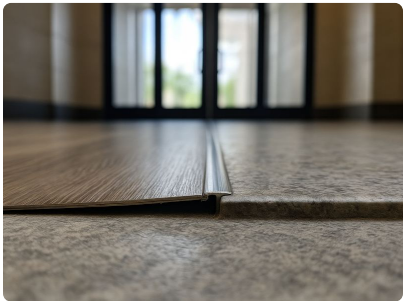
Attached picture

Height mismatch and a visible gap where the lobby LVT plank flooring meets the stone entry threshold — transition strip wasn't seated flush, creating a trip hazard right at the main entrance. Needs the strip reset and, if needed, additional leveling compound under the LVT edge.

Slab must've been slightly low right at the threshold. We'll pull the strip, add leveling compound under the LVT edge, and reset it flush.
-

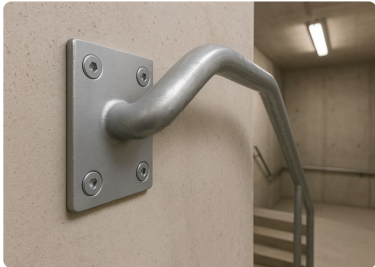
- 
- Attached picture
- Wall-mounted handrail bracket at the Floor 6 landing of Stairwell C has pulled slightly away from the wall — anchor screws backed out, rail flexes under hand pressure. Life-safety egress item, needs immediate re-anchoring with appropriate fasteners for the substrate.

Heading up now. Original anchors were sized for solid concrete but that section's block — will swap to the correct sleeve anchors for block wall so it doesn't happen again.

Re-anchored with block-rated sleeve anchors, torqued to spec, rail doesn't budge under load now. Touched up paint on the anchor points. After photo attached. Also checked the other brackets on that run — all solid.

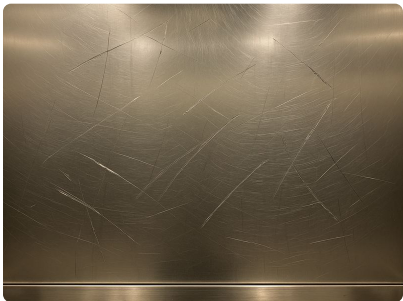
Attached picture

Rear stainless steel wall panel in Elevator 2's cab has visible scratch/gouge marks, likely from move-in of MEP equipment through the cab before floor protection was installed. Needs panel buffed out or, if scratches are too deep, replaced.

Took a look — scratches are shallow enough to buff out with a stainless finishing pad, won't need a panel swap. I'll get a tech out this week and we'll put floor + wall protection back up after.
